GU Ferco Munster Joinery 35/70

1 x Sash/Latch, 2 x Rollers, 1 x Bolt

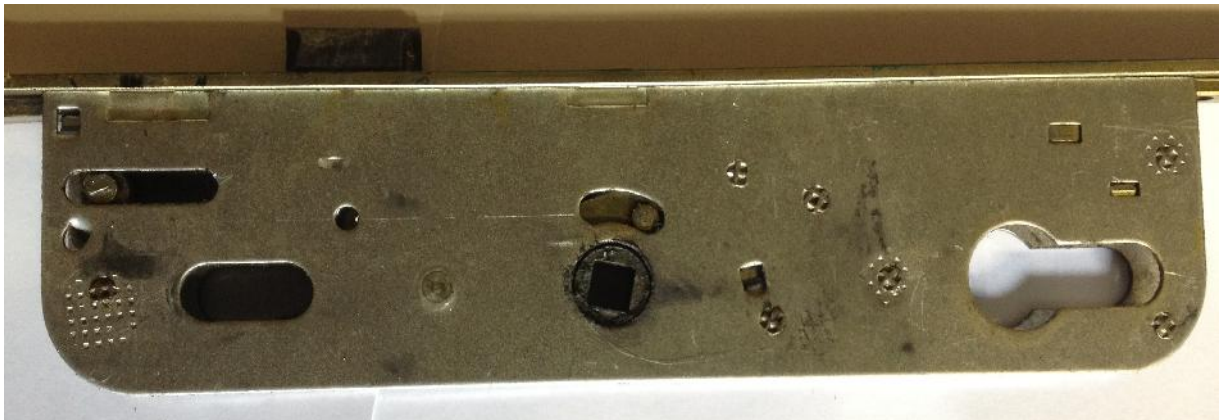
Top Picture - Munster 35/70 Lock Case

The most frequent problem is caused by the bolt situated in lower half of door. This can be caused by the door being closed with bolt extended or by the wood warping and causing excessive pressure on the bolt entering and leaving the keep resulting a fractured spindle.
