LOCKMASTER

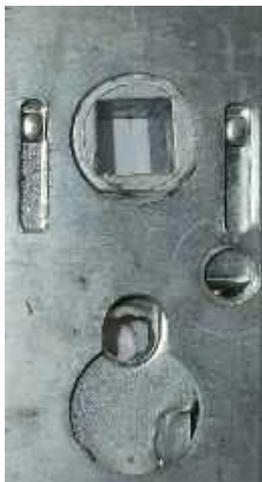
LH Side

From the LH side the upper spindle follower has a cut-out at the bottom and grooves approx 3mm either side.

Various different failures but most common is the gearbox seizing due to broken latch retractor or cam follower. Early models are passivated yellow, later ones are steel cases. Once the handles are removed it has distinctive spindle followers. The lower hole in the picture is for another spindle follower for the split spindle version.

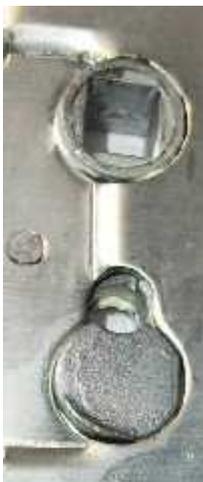
From the RH side the circumference of the spindle follower is uninterrupted but note the distinctive ridge that falls away to the left.

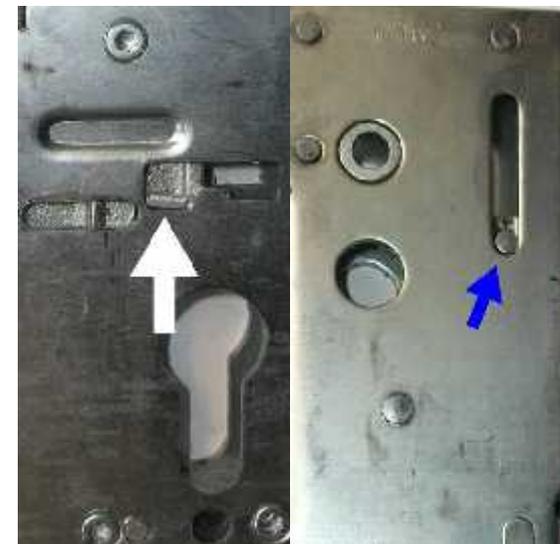
Profile will not unlock: Broken cam follower, 17mm up and 5mm fwd on either side, lift tab (white arrow) and slide back. This should retract the bolt, if not then go forward another 5mm to collect the front part of the cam follower.

Profile unlocks but latches not retracting:

RH side: 150mm up and 23mm fwd (blue arrow) from top centre of profile. Push nipple up. This might be outside the handle profile.

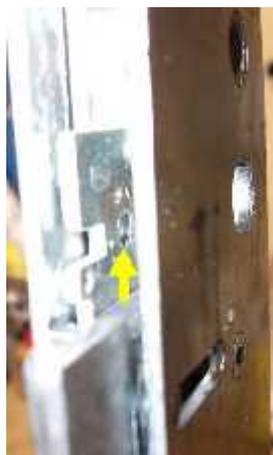
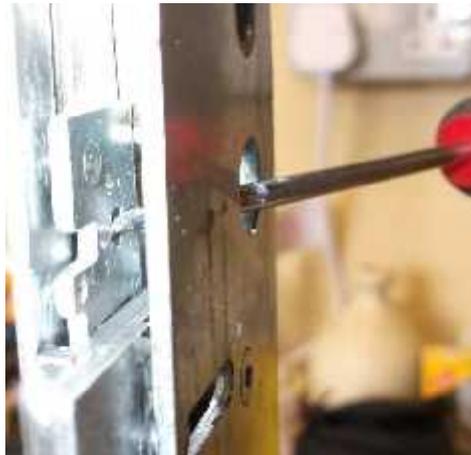
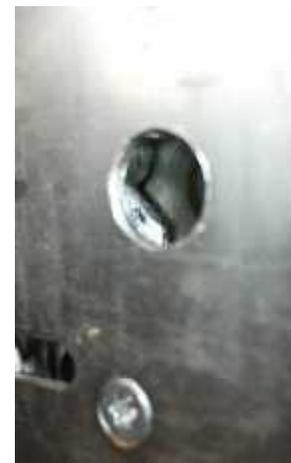
LH side: Locate hole already in case 140mm up, (red arrow). To the left you will see a plate with a small hole in it (yellow arrow) angle small screw driver in and lift the plate approx 10mm after which you should then see a V notch in the plate. Lift the plate as high as possible to complete the retraction of the mechanism. If you cannot get a tool onto the plate then drill a hole approx 10 mm fwd, inside the handle profile.
